CARR-1450
John Dorsey Farm
Gaither (vicinity)

Maryland Historical Trust State Historic Sites Inventory Form

historic John Dorsey Farm

street & number 6271 Old Washington Road not for publication

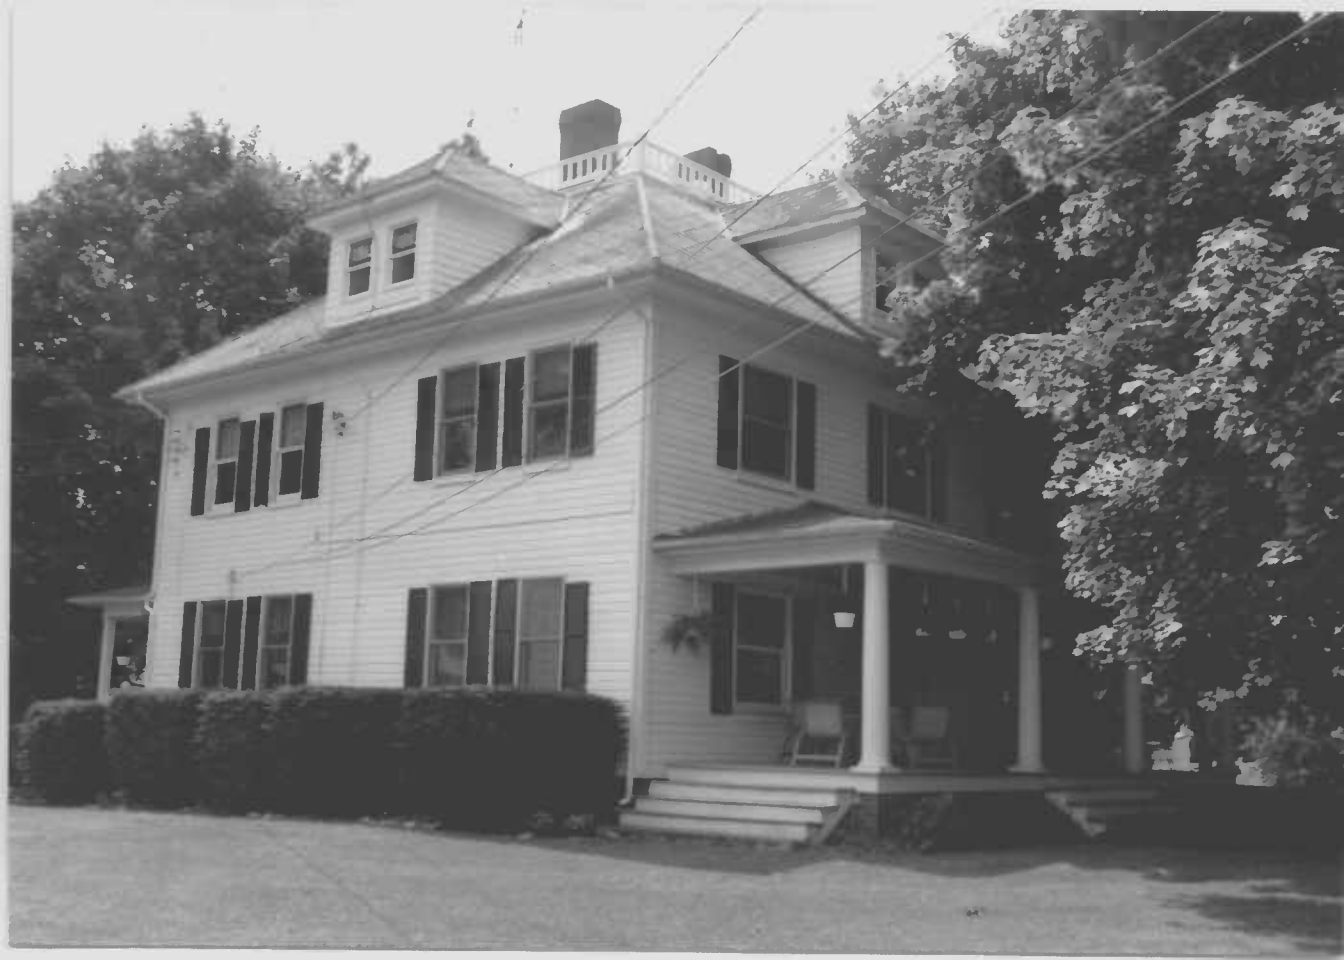
John Dorsey Farm
6271 Old Washington Rd.
Carroll County, Maryland
Photo: Kenneth M. Short
Date: June 1995
Neg. Loc.: Maryland Historical Trust
house - NE & NW elevs
1/4

The house is a 2½-story, three-bay by four-bay frame structure with a rubble stone foundation, German siding with corner pilasters, and a hip roof with diamond-pattern asphalt shingles and a widow's walk with a vertical-board balustrade at the peak. There are two interior brick chimneys inside the widow's walk. The German siding is unique in that it has an ovolo moulding, instead of the more traditional cavetto or bevel. The house faces northwest towards the road. On the northwest elevation, the first story has a central door with one large light, and sidelights with three lights over one panel. There is a four-light transom. There is a 1/1 sash on either side of the doorway. The first story has a one-story, three-bay porch set on brick piers, with Greek Doric columns and a half-hip roof. The second story has three 1/1 sash. There is a dormer on the roof with two 1/1 sash, wood shingles on the northwest elevation, and a hipped roof with a lightning rod. The house has a wood box cornice with a wide eave.

The northeast elevation has two four-light casements in the foundation. The first story has four 1/1 sash set in two pairs, one in each end. The second story is identical to the first. There is a dormer on the roof identical to the northwest elevation. The southeast elevation has a one-story, three-bay porch, 2½ bays of which are enclosed. The porch has square boxed posts on brick piers and a half-hip roof. The east end of the porch has an original five-lying-panel door that leads to the house. The second story of the southeast elevation has three 1/1 sash and a five-lying-panel door set between the south and south-center bays. There is a railing along the top of the south end of the porch. The roof contains a typical dormer. The southwest elevation has a four-light casement in the west bay of the foundation. The south bay has hurricane doors. Just west of these is a low stone foundation with concrete on top and a four-light casement on the southwest. The first and second stories have four 1/1 sash, like on the northeast elevation, and the roof has a typical dormer.

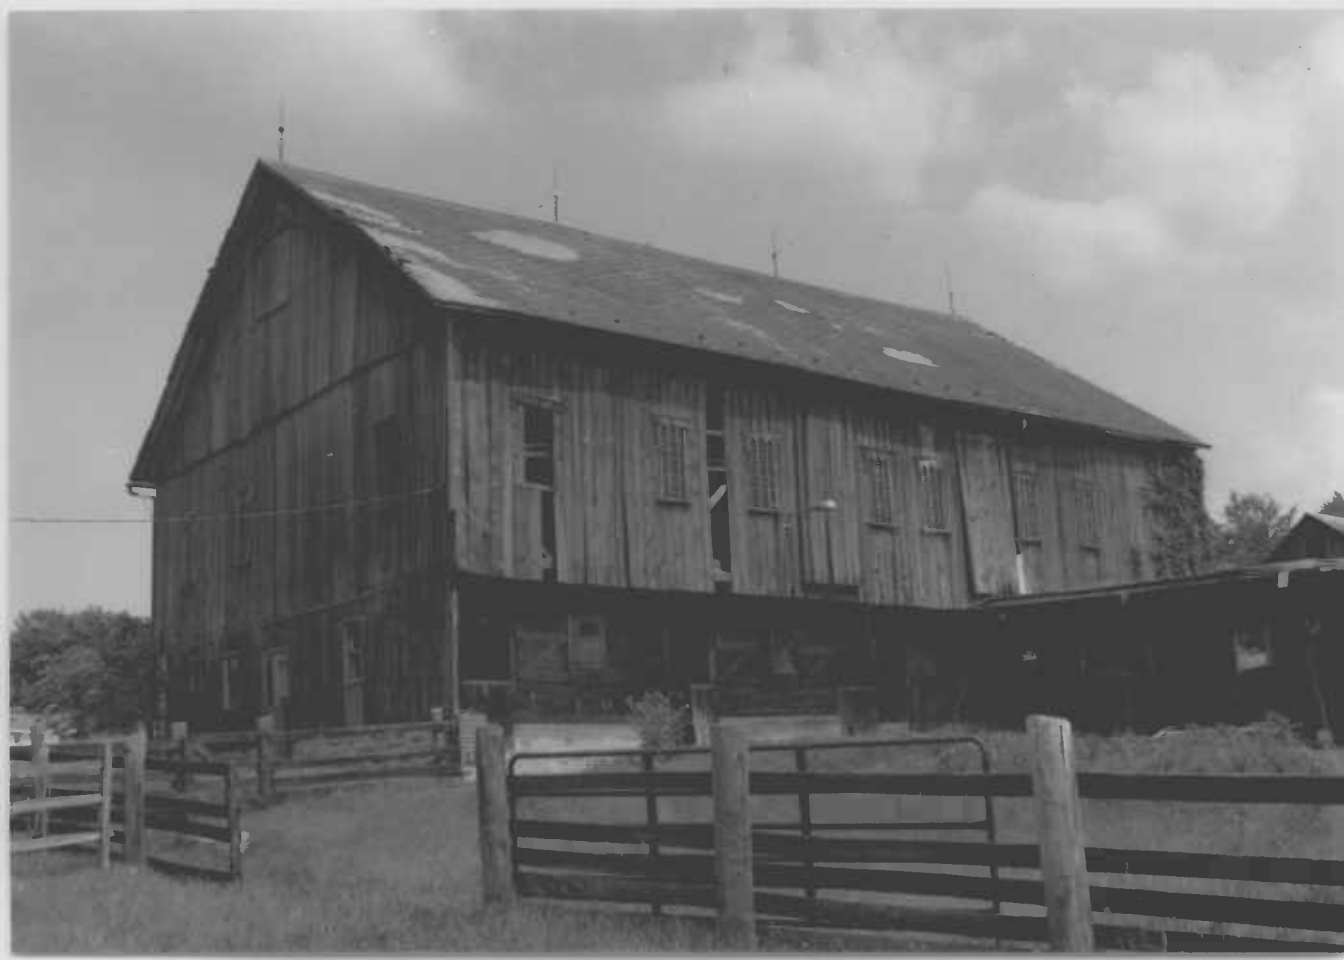
2/4

Neg. loc.: Maryland Historical Trust
barn - SW & SE elevs.

About 200 feet northeast of the house is a bank barn with a forebay that faces southeast. The southeast elevation lower story has horizontal beaded-edge-and-center boards. The doors have beaded-edge-and-center vertical boards. They are dutch doors hung on machine-cut strap hinges, while the windows in this story have 6/6 sash. The lower story has, from south to east, a door, a window, a door, a window, two doors, a window, a door, a window, and a door. There is a stone wall on the east end underneath the forebay and a steel post at the south corner of the bay. The upper story has vertical-board siding. There are three vents to the south, then a vertical board door on rollers, two more vents, another door, and three vents to the east. The barn has a gable roof with diamond-pattern asphalt shingles and four lightning rods. The southwest elevation lower story has vertical-board siding, with an opening, a 6/6 sash, a typical dutch door, and another 6/6 sash. The upper story has three vents. The gable end vent has been closed up, but retains a pediment above the opening with dentils and a drop pendant. The northwest elevation lower story has an addition on the north side. The west side of the ramp has a stone wall. The west side of the barn has a 4/4 sash. Each sash is set on its side. The upper story also has an addition on the north side. The southwest elevation of this addition has a doorway. The barn has two pair of wagon doors on rollers in the center of the northwest elevation, then two vents with window openings in the bottom of them, to the west. The northeast elevation has two 4/4 sash set on their sides in the lower story. The upper story also has three vents. The gable end has two vents, and there is an opening in the peak with the same pediment as found on the southwest elevation.

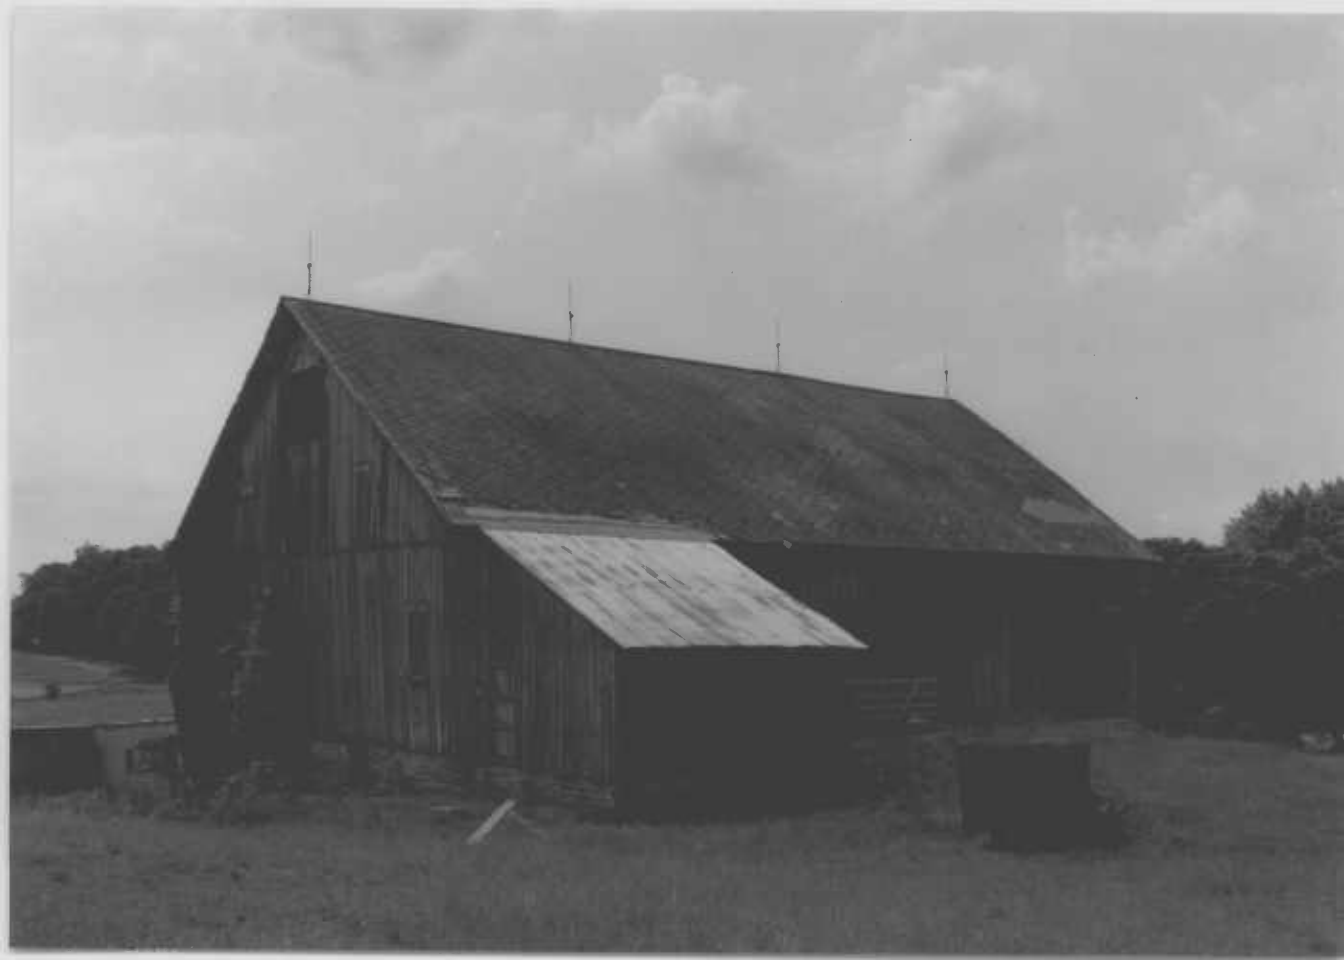
John Dorsey Farm
6271 Old Washington Rd.
Carroll County, Maryland
Photo: Matt Hankins
Date: January 1995
Neg. Loc.: Maryland Historical Trust
barn-NE & NW elevs.
3/4

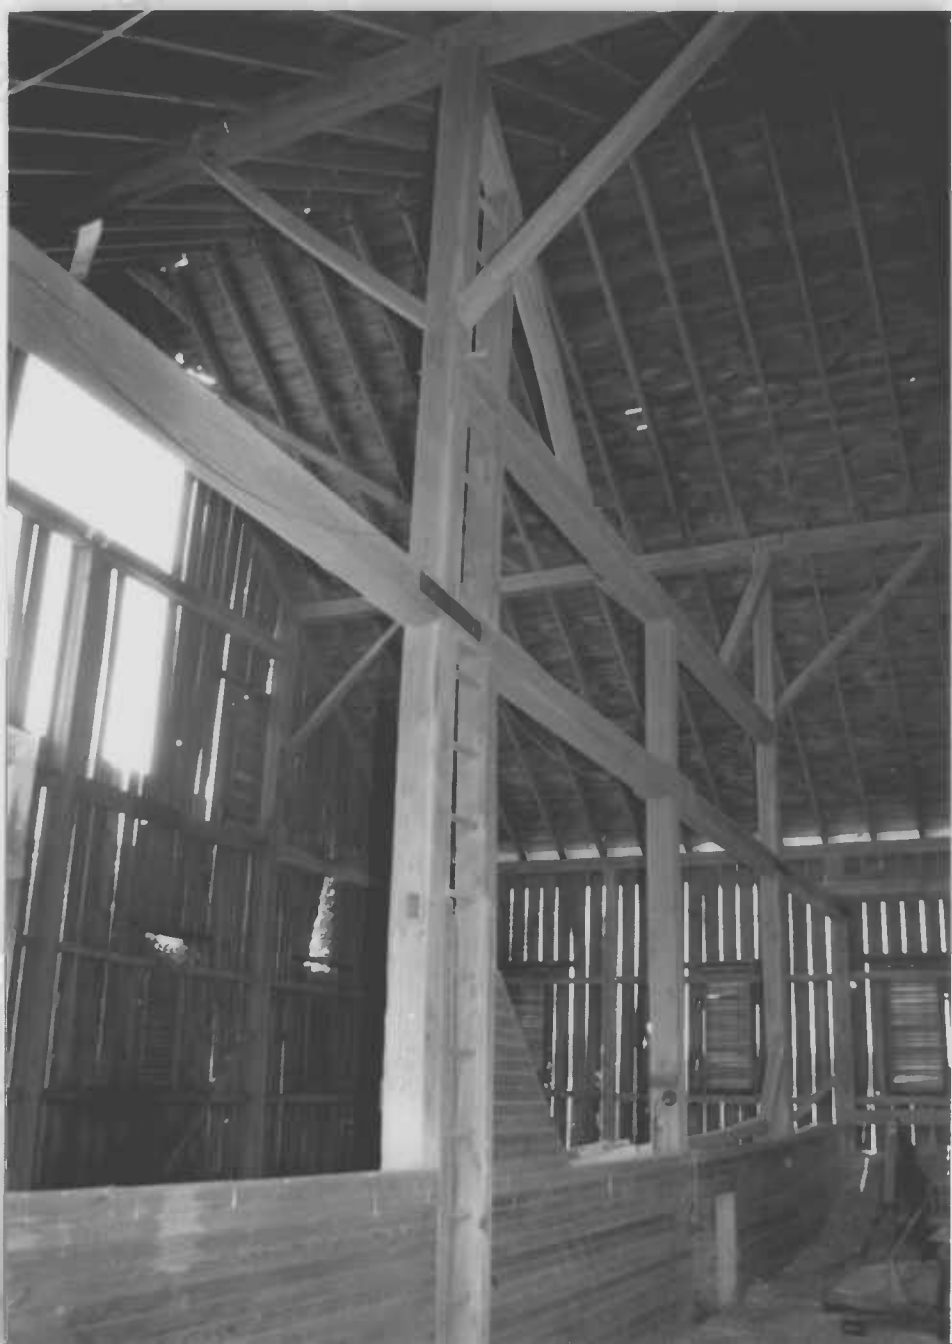
4/4

Neg. loc.: Maryland Historical Trust
barn - upper story bent

The lower story of the barn has three summer beams with five posts under each and block capitals on top of the posts beneath the summer beam. The posts are mortised and tenoned and pegged into the blocks. The blocks have chamfered corners, and the summer beams have half-lap scarfs that are pegged. All of the timber is circular sawn. The joists

run northwest to southeast from the northwest wall to the northwest summer beam, then from the northwest summer to the southeast summer, and finally, separately, from the southeast summer to the forebay. Several of the joists are only of two pieces, with a half-lap scarf and two pegs at the center summer beam. The southeast wall is frame, set on a low concrete foundation. The southwest wall is frame on a low stone foundation. The upper story has two center threshing floors and a hay mow on each end. There is a granary in the west corner. The barn has five circular-sawn bents that are mortised and tenoned and pegged. Each bent has five posts. The bents have a Queen post truss supporting the roof. The top girt connecting the Queen post truss has through-tenons with wedges. The center girt has metal straps fastening it to the posts, as well as pegged joints. The rafters are approximately 2 x 4's that are mitered at the ridge, and there is a hay track. The barn is slated for demolition.
